Site name: Northwest Branch at White Drive

Assessment Area: 1

Key Wildlife Habitat type: Montane-Piedmont Seepage Swamp

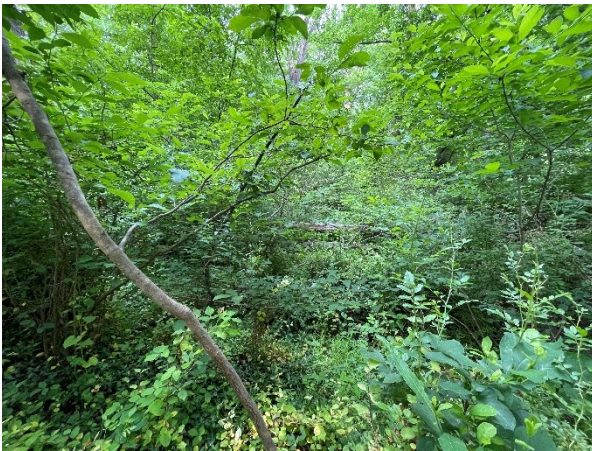
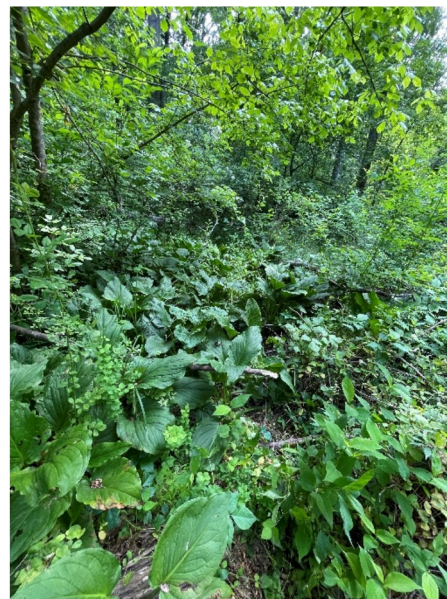
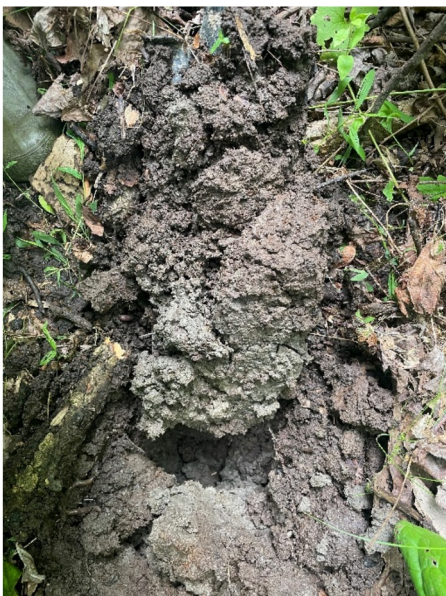
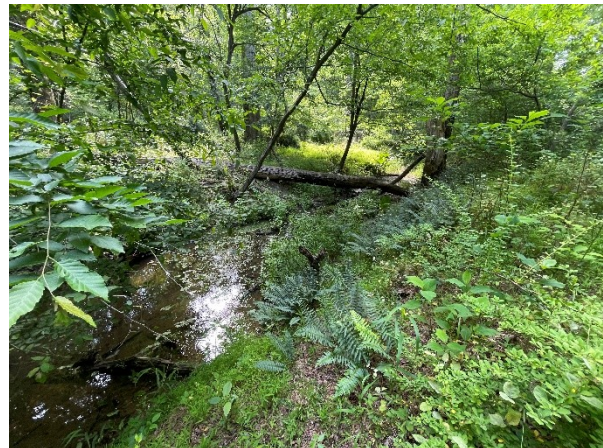
Site Photos (Including photo of soil sample with surface layer at the top and nearest stream reach):

This site is a small area of groundwater seep adjacent to a trail feeding an extremely slow-moving small stream which feeds into the Northwest Branch Anacostia River. The vegetation and woody debris at this site has been altered by Emerald Ash Borer and includes a dead Ash log 27 inches in diameter which previously fell onto a hiking trail. The soil at this site contained less than 10% redox concentrations starting 0-6 inches from the soil surface, and the mineral surface horizon was greater than 4 inches thick

and had a munsell color of 7.5YR 2.5/1. The channel showed minimal evidence of instability/migration, but did have relatively steep banks, and was minimally disconnected from its floodplain. The vegetation in this site was dominated in the tree stratum by *Carpinus caroliniana* and *Liriodendron tulipifera*, the sapling/shrub stratum was dominated by *Acer negundo*, *Lindera benzoin*, and *Sambucus canadensis*, the herb stratum was dominated by *Symplocarpus foetidus* and *Vinca minor*, and the woody vine stratum was dominated by *Lonicera japonica*, *Toxicodendron radicans*, and *Smilax rotundifolia*. Invasive species present include *Rosa multiflora*, *Vinca minor*, *Alliaria petiolata*, *Berberis thunbergii*, *Microstegium vimineum*, *Potentilla indica*, and *Lonicera japonica*. Despite the number of invasive species present at this site, this site is in good condition overall and is a good example of a smaller seepage swamp site.
